JUNO-106

SUBJECT

COUNTERMEASURE TO MEMORY BACK UP BATTERY

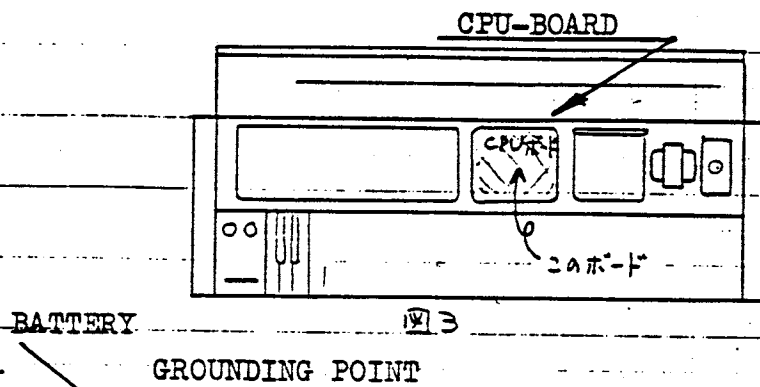
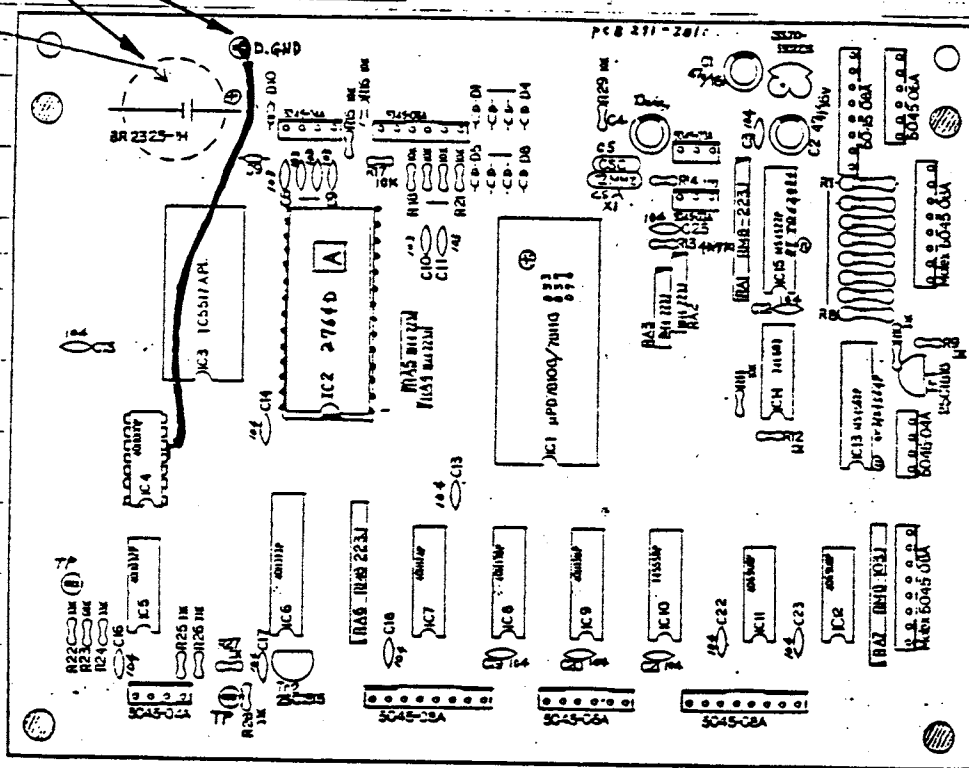
JUNO-106 MODIFICATION

It was found that JUNO-106 is likely to break memory data in a short period as IC-4 40H000P on CPU BOARD draws a variance current ranging 250 micro ampere to zero.

The "floating" inputs (pins 4 and 5) of the unused section of IC-4 40H000P are the cause of this problem. The solution is that they should be connected to ground point by using a jumper wire. Please refer to the attached drawing.

NOTE: Firstly, connect a jumper wire to above ground point to prevent breaking IC from happening on, and then, connect the jumper wire to pins 4 and 5 of IC-4.

Pins 4 and 5 must be connected to grounding point by using a jumper wire.
